Renishaw CMM Products Division

PRODUCT BULLETIN – PBC1209

| Title: | Compliance with Windows Vista® | Date: | 9th May 2008 |

UCC2 Firmware Updater – Customer Instructions

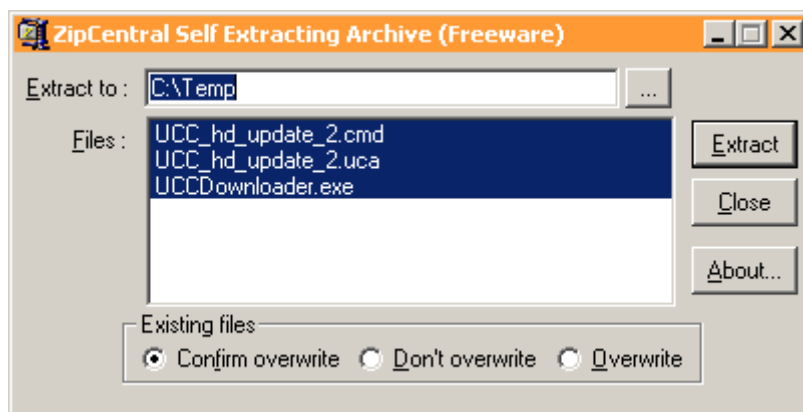
- 1) When you have downloaded the UCC2 updater program, "UCC_hd_update_2.exe", from the UCCserver website, or copied it from a transfer device (CD ROM, memory stick, etc), it should be saved in a folder on the PC's hard drive.
- 2) "UCC_hd_update_2.exe" is a self-extracting executable. Using Windows Explorer locate the "UCC_hd_update_2.exe" file and double-click it. This will open a dialogue box similar to the following:

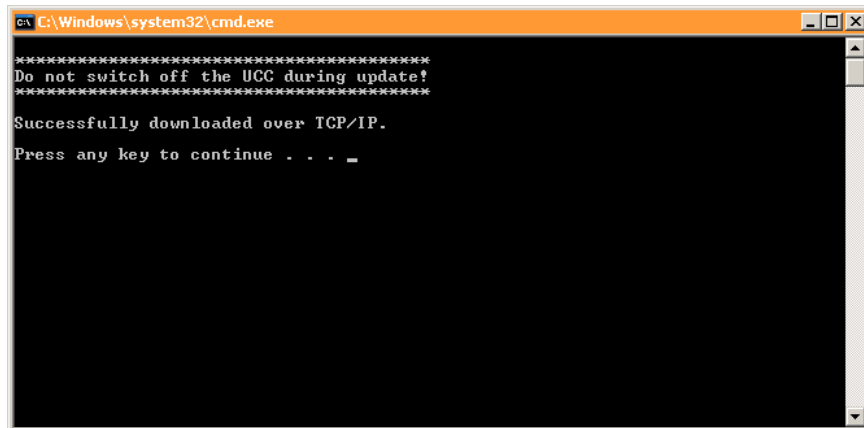
8) Double-click "UCC_hd_update_2.cmd". This opens a Command Prompt window and downloads the update to the UCC2. It may take up to 30 seconds to get to the point where you are asked to press any key to continue:

```
C:\Windows\system32\cmd.exe
*****
Do not switch off the UCC during update!
*****
Successfully downloaded over TCP/IP.
Press any key to continue . . . _
```
