Renishaw CMM Products Division PRODUCT BULLETIN – PBC1624

Product: UCC Software	Status: Open
Title: Launch of UCCsuite 4.5	Date: 24 th October 2012

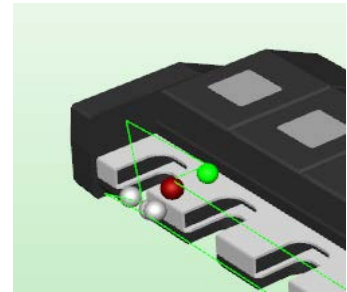
- UCCsuite 4.5 includes an overhaul of its rack alignment routines/GUI. Initial joystick alignment is guided by a bouncing ball graphic. The red ball is the next point; the green ball represents taken points.

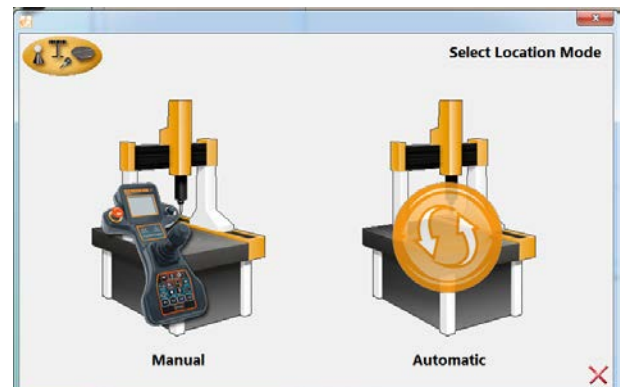
- After joystick alignment, the user is presented with a choice of old "Manual" method for each port or CNC "Automatic" for all ports.
